Statement explaining additional imagery:

The Motor Tanker (M/T) Kokuka Courageous sustained damage from a limpet mine attack while operating in the Gulf of Oman, on June 13th. Limpet mines are attached to a vessel via magnets and/or nails and detonated by a timer. Following the attack, sailors from the Kokuka Couragous discovered a second, unexploded, limpet mine on their vessel and abandoned ship. The Dutch tug Coastal Ace rescued the crew of 21 sailors. The USS Bainbridge (DDG 96) then transferred and transported the Sailors to safety. Later that day, an Islamic Revolutionary Guard Corps (IRGC) Gashti Class patrol boat approached Kokuka Courageous and was observed and recorded by a U.S. Navy MH-60R helicopter removing the unexploded limpet mine from Kokuka Courageous. Iran is responsible for the attack based on video evidence and the resources and proficiency needed to quickly remove the unexploded limpet mine. The hull penetration measures 1.1m at the widest point by 1.5m 4'2" x 3'8" (H x W) at the tallest point. The penetration begins approximately 1m above the water line.

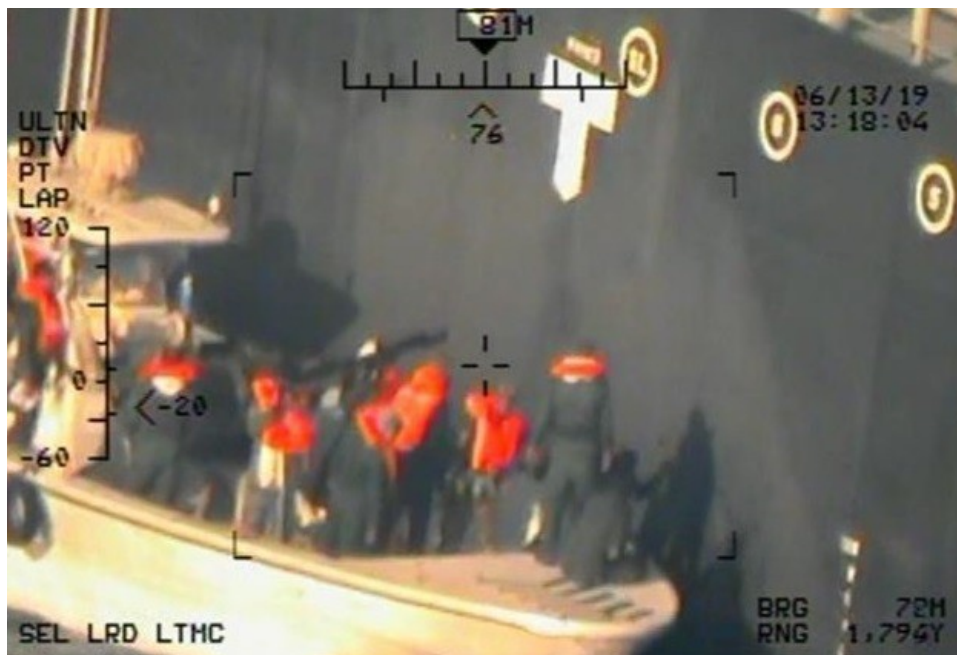
Imagery taken from a U.S. Navy MH-60R helicopter of the Islamic Revolutionary Guard Corps Navy removing an unexploded limpet mine from the M/T Kokuka Courageous.

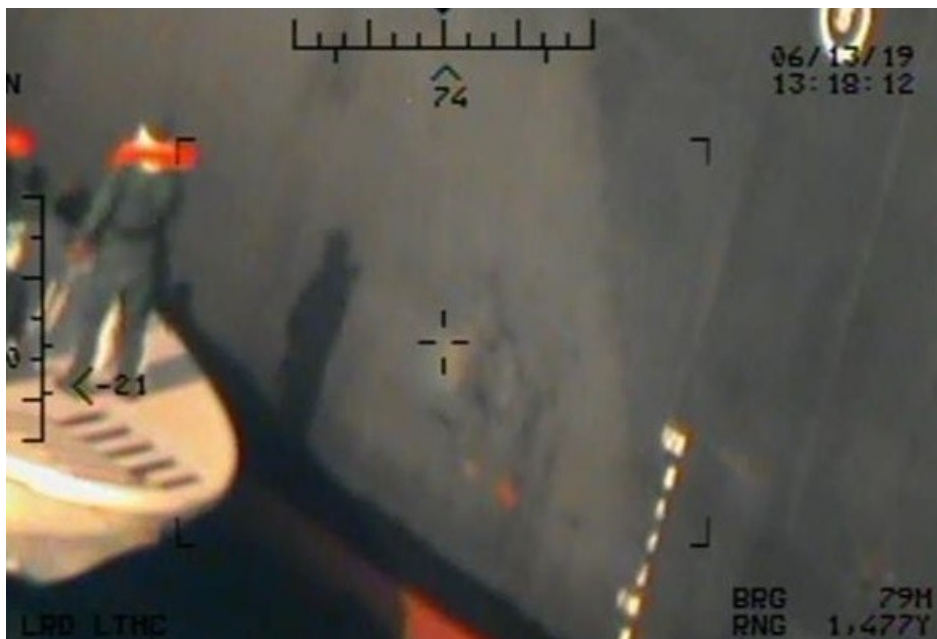
Imagery taken from a U.S. Navy MH-60R helicopter of the Islamic Revolutionary Guard Corps Navy after removing an unexploded limpet mine from the M/T Kokuka Courageous.

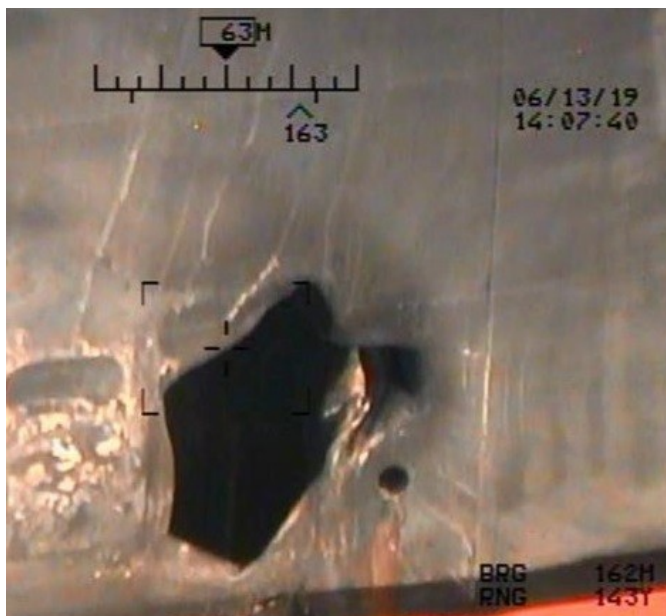
| Imagery taken from a U.S. Navy MH-60R helicopter of blast damage to M/T Kokuka Courageous. M/V Kokuka Courageous received damage consistent with a limpet mine attack in the Gulf of Oman, June 13.

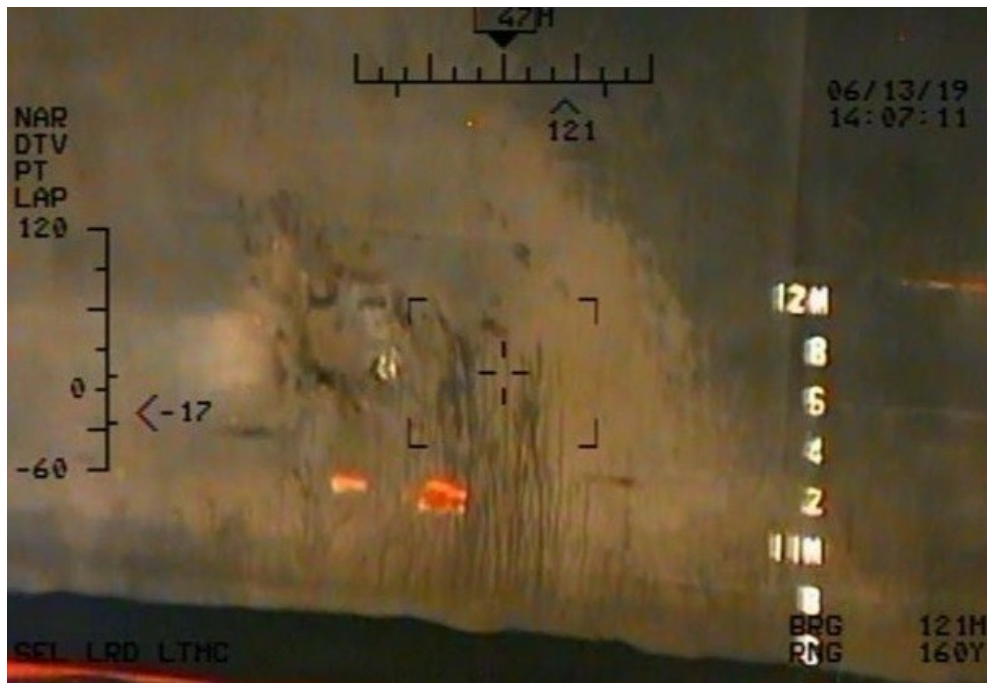
Imagery taken from a U.S. Navy MH-60R helicopter of the Islamic Revolutionary Guard Corps Navy of the remnants of the magnetic attachment device of unexploded limpet mine from the M/T Kokuka Courageous.

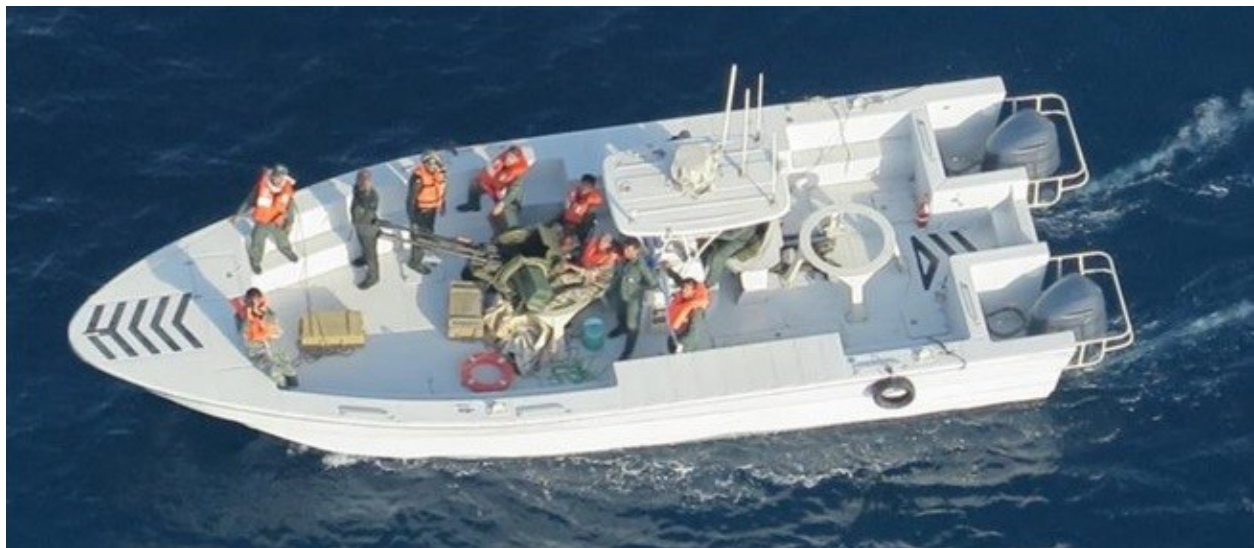
Imagery taken from a U.S. Navy MH-60R helicopter of the Islamic Revolutionary Guard Corps Navy after removing an unexploded limpet mine from the M/T Kokuka Courageous.

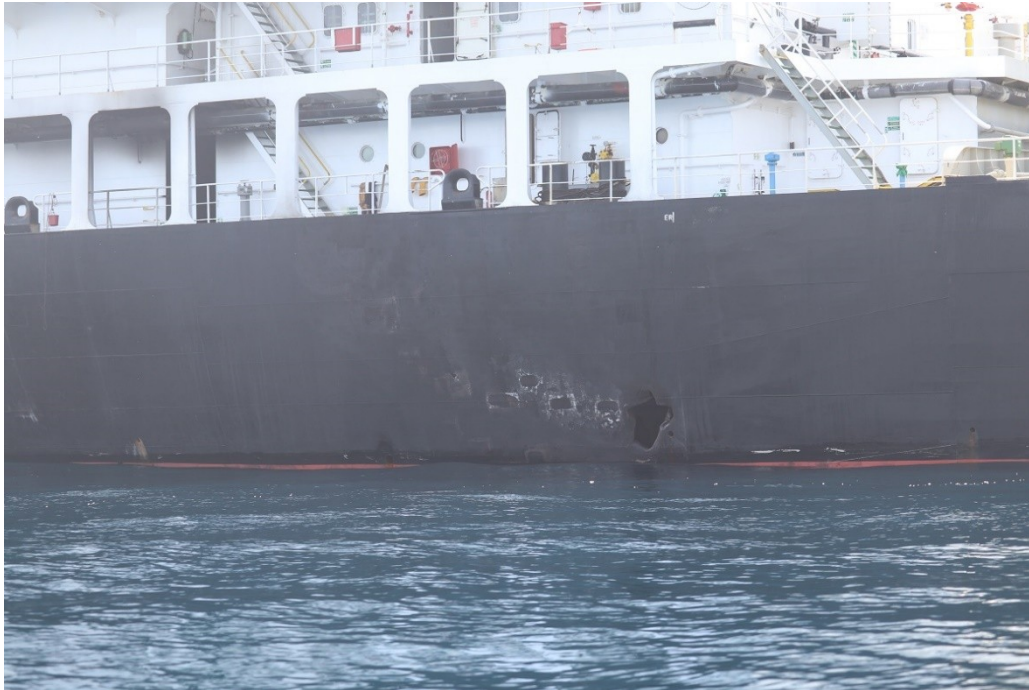
7710 – This is a view of hull penetration/blast damage on the starboard side of motor vessel M/T Kokuka Courageous, which was sustained from a limpet mine attack while operating in the Gulf of Oman, on June 13th.

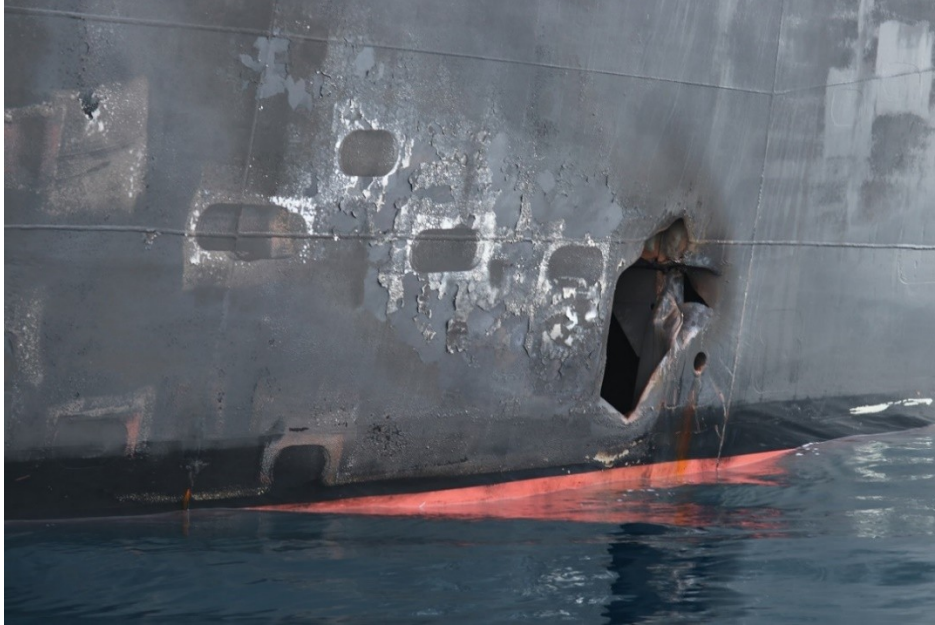
7725 - This photo is a view of hull penetration/blast damage sustained from a limpet mine attack on the starboard side of motor vessel M/T Kokuka Courageous, while operating in the Gulf of Oman, June 13.

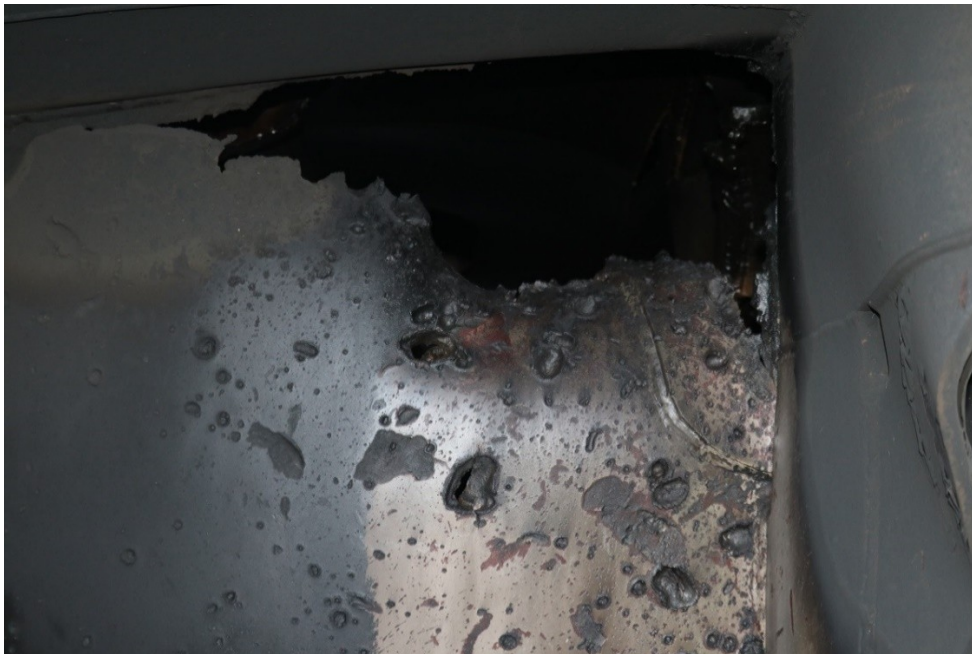
7729 - This photo is a view of internal hull penetration/blast damage sustained from a limpet mine attack on the starboard side of motor vessel M/T Kokuka Courageous, while operating in the Gulf of Oman, June 13.

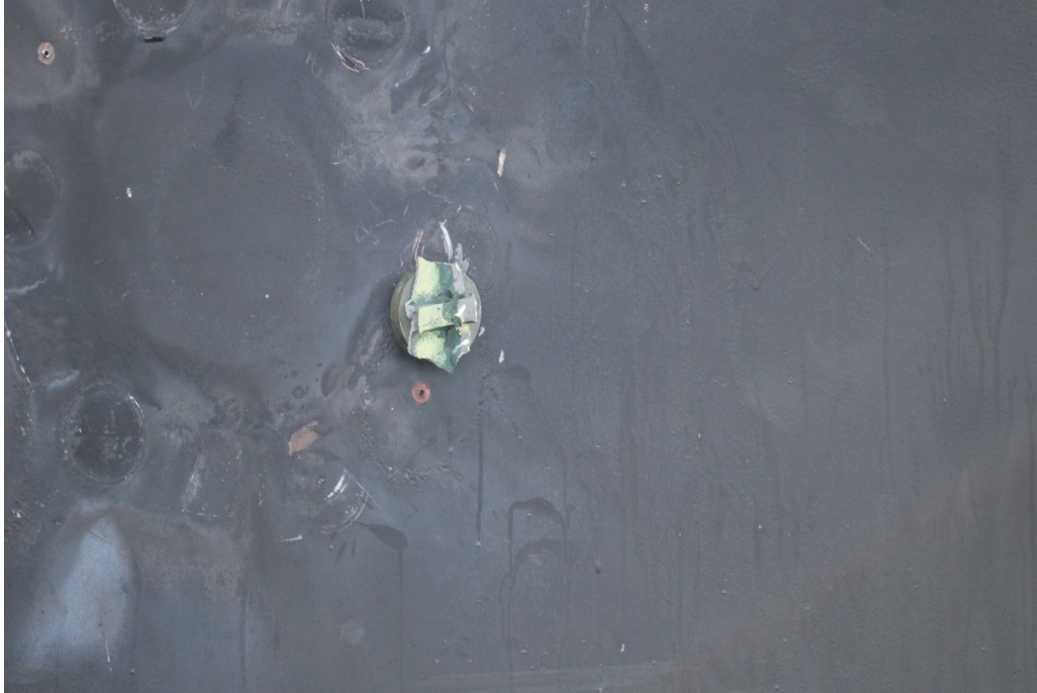
7714 - This is the view of the remnants of a removed limpet mine's placement, location, and damage sustained from a limpet mine attack, on the starboard side of motor vessel M/T Kokuka Courageous, while operating in the Gulf of Oman, June 13. A limpet mine is attached to a vessel via magnet and/or nails. The holes seen were created by nails used to hold the mine in place.

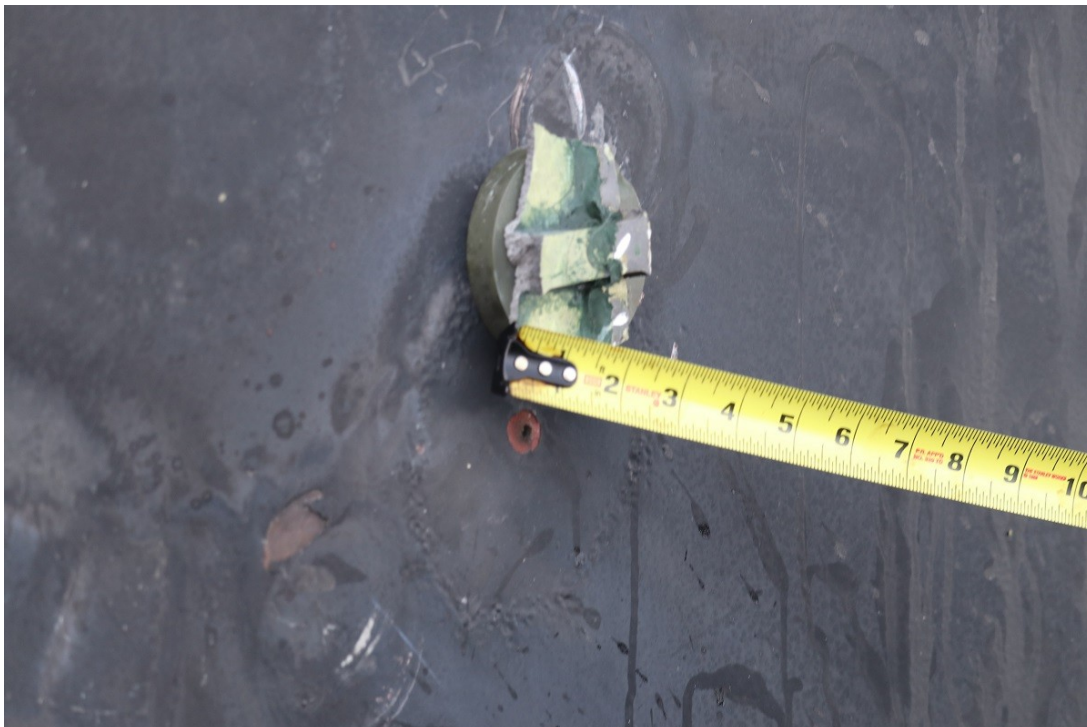
7761 -This photo depicts the aluminum and green composite material left behind following removal of an unexploded limpet mine used in an attack on the starboard side of motor vessel M/T Kokuka Courageous, while operating in the Gulf of Oman, June 13th.

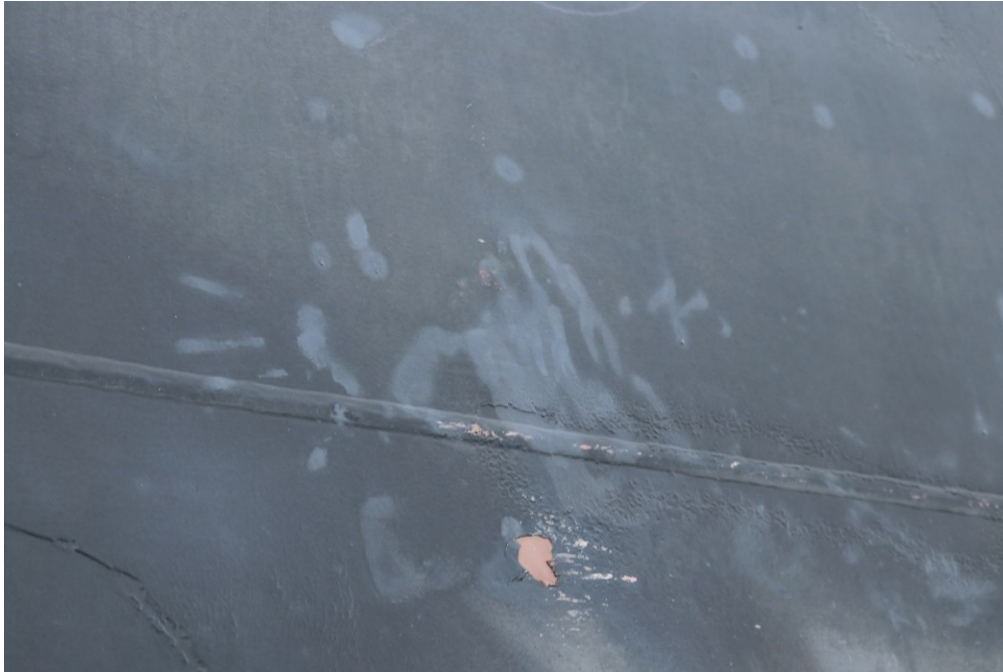
7760 - This photo depicts a handprint from the individual who removed the limpet mine used to attack the motor vessel M/T Kokuka Courageous, attacked while operating in the Gulf of Oman, June 13.
